Test Report

No. CKGEC2300888941

Sample Name : Optic glass

Model No. : H-BAF7

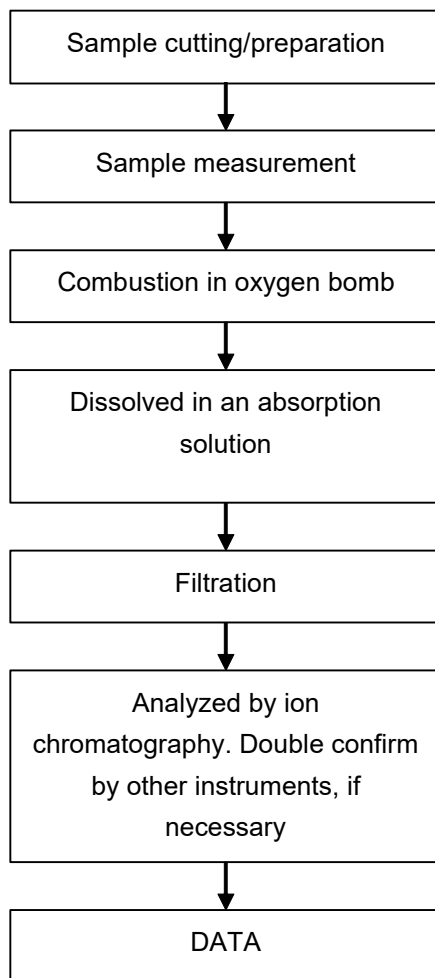
Halogen and Sulfur Testing (oxygen bomb) Flow Chart

Test Method : With reference to EN 14582: 2016, analysis was performed by Ion Chromatograph (IC).

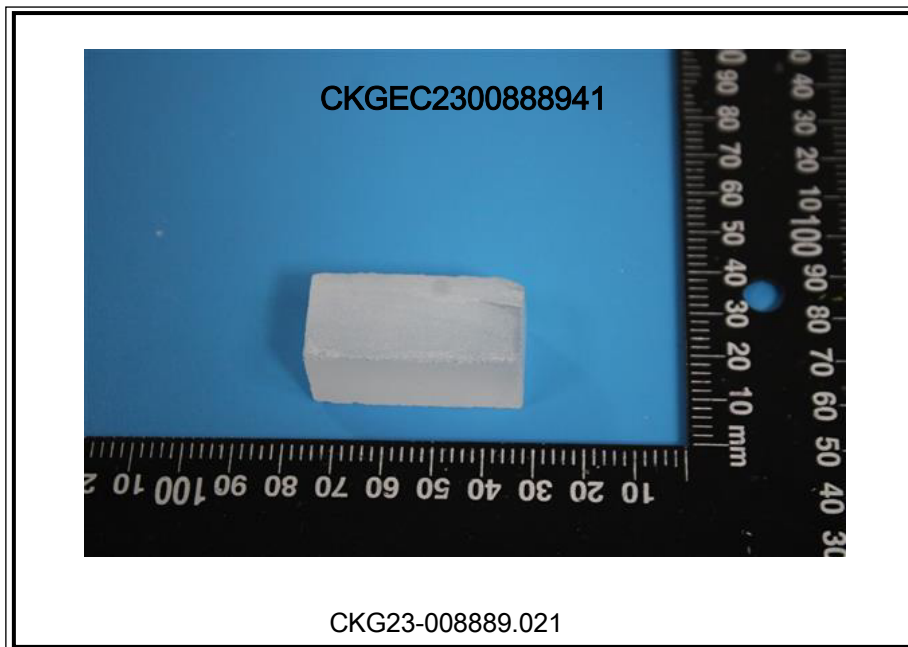
Sample photo:

Specimen No.	SGS Sample ID	Description
SN1	CKG23-008889.021	Colorless transparent glass
